NIST NCSTAR 1-2

**Federal Building and Fire Safety Investigation of the
World Trade Center Disaster**

Baseline Structural Performance and Aircraft Impact Damage Analysis of the World Trade Center Towers

September 2005

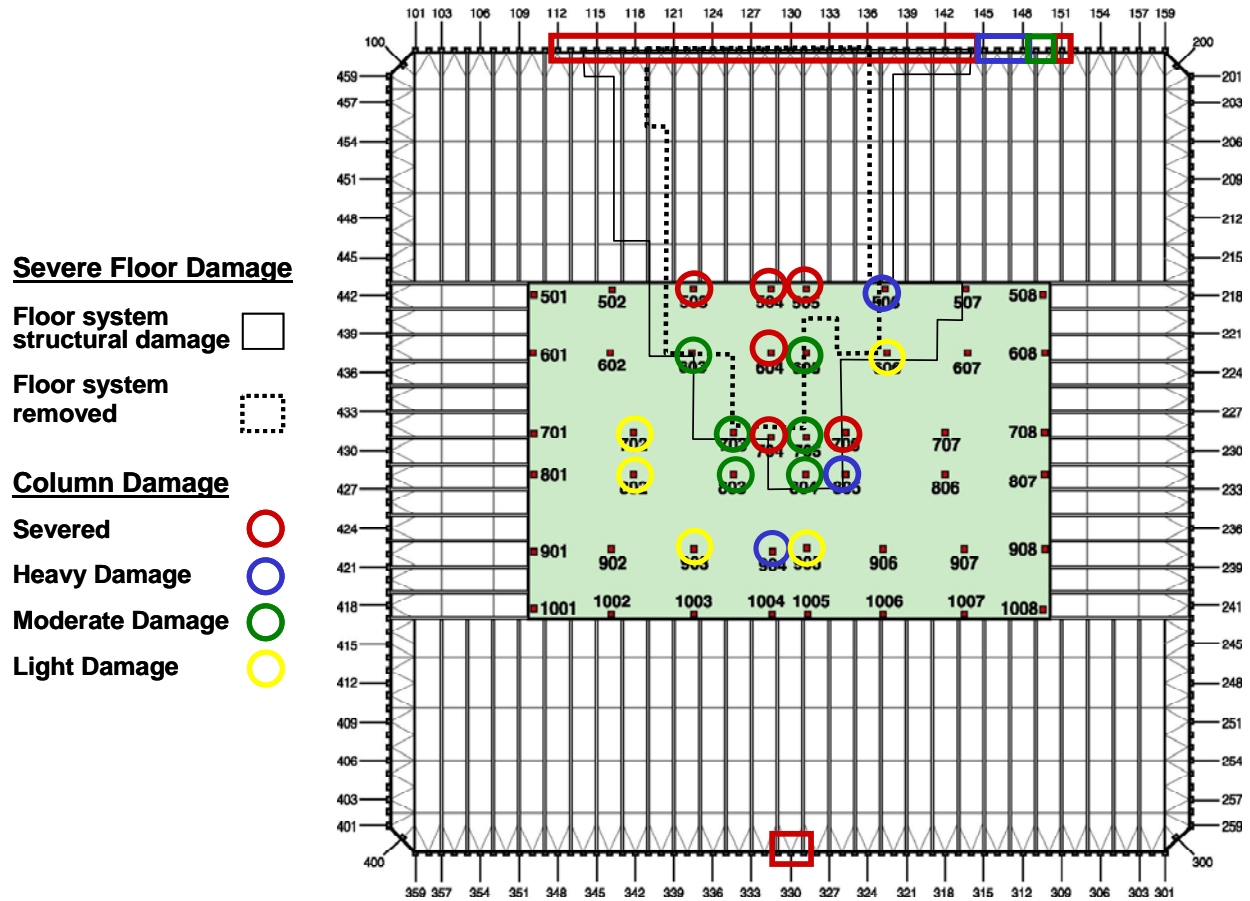
Figure E-42. Cumulative structural damage to the floors and columns of WTC 1 (more severe case).

Figure E-42 presents the cumulative damage to WTC 1 on all affected floors and columns for the more severe case.

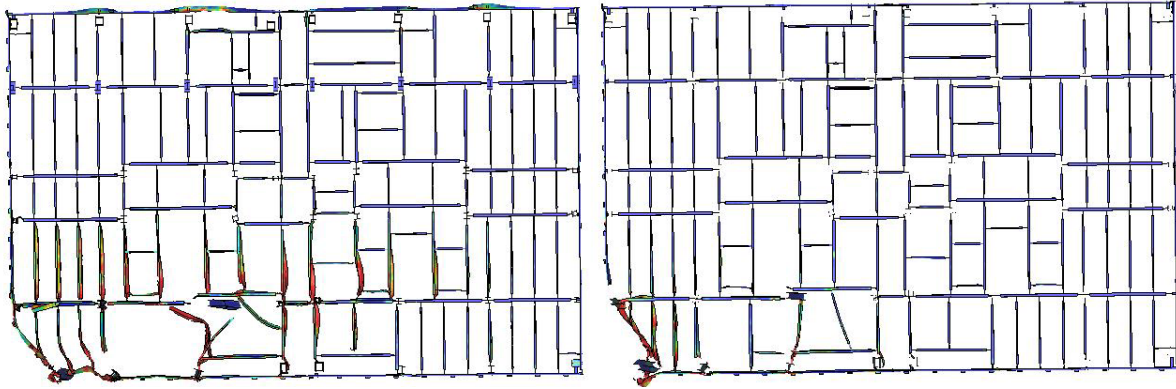
(a) Floor 80 core framing damage **(b) Floor 81 core framing damage**
Figure E-48. Base case impact damage to the core beams of floors 80 and 81 of WTC 2.

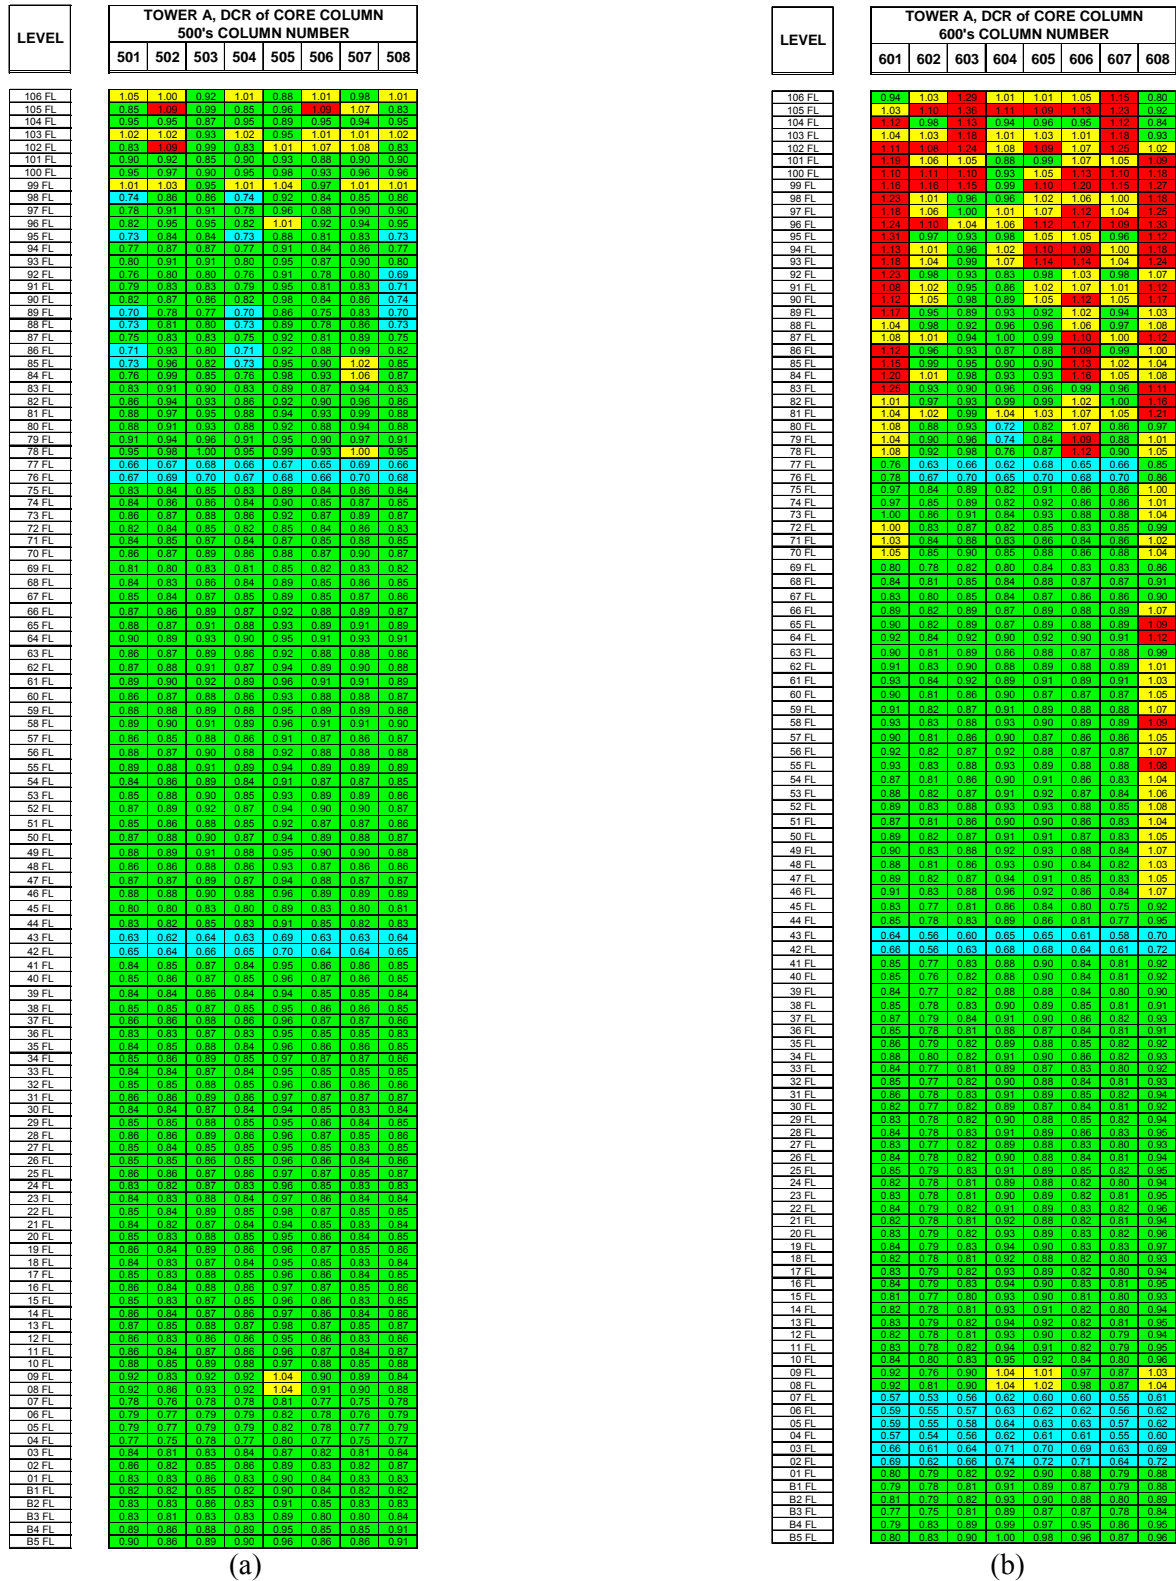
Figure 4-5. DCRs for WTC 1 core columns under original design loads, (a) 500 line, and (b) 600 line.

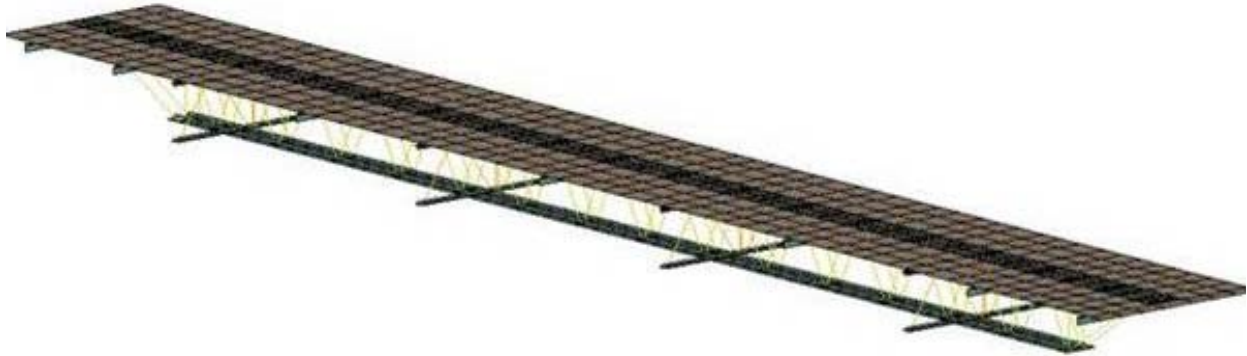
individual truss floor segments spanned the distance from the exterior wall to the core. An example of a truss floor segment used in the global model is shown in Figure 5–12. In the double truss sections, the two trusses were modeled explicitly with the proper dimensions.

Figure 5–12. Model of a truss floor segment.

The floor truss model was developed using a uniform layer of Belytschko-Tsay shell elements for the combined floor slab and metal decking, Belytschko-Tsay shell elements for the truss upper and lower chord components, and Hughes-Liu beam elements for the round bar truss diagonals. The upper chord was attached to the floor slab using a tied interface. This approach, using shell elements as opposed to solid brick elements for the floor slab, was adapted to reduce the model size requirements. Development of a model with matching mesh density in the slab and truss structures (nodal alignment for a merged connection) resulted in a much larger model size. Bridging trusses were modeled in a similar fashion to the primary trusses.

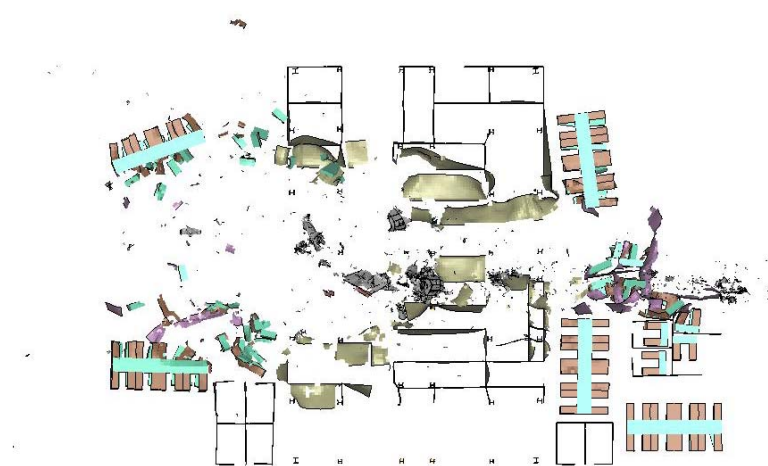
(c) Calculated impact response (fuel removed)

Figure 7–30. Calculated more severe WTC 1 impact response of floor 95 contents.

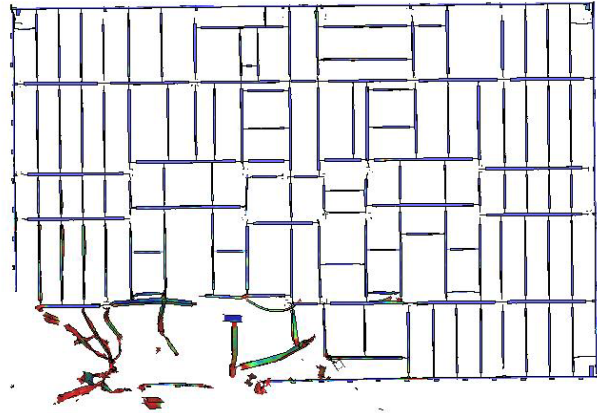
Figure 7-52. More severe impact damage to the core beams of floors 80 and 81 of WTC 2.

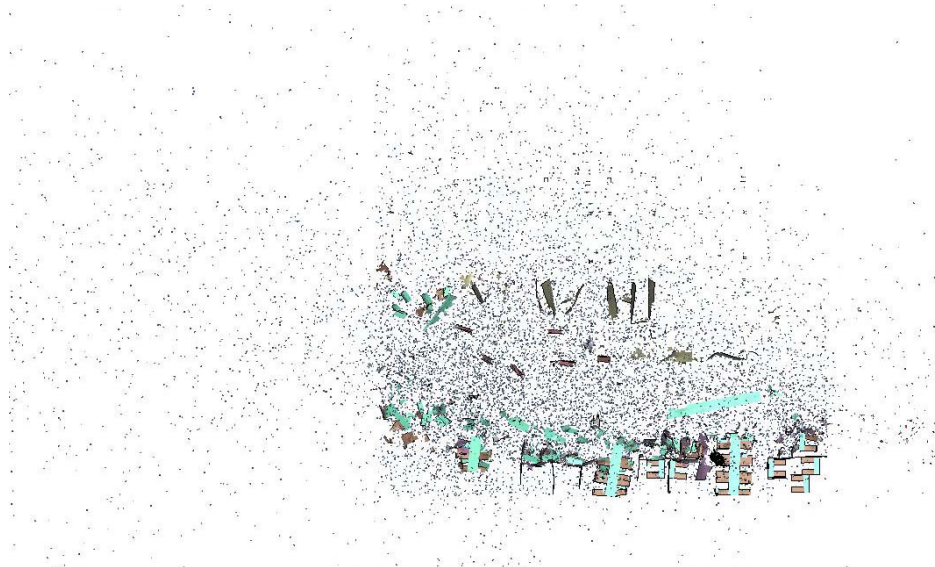
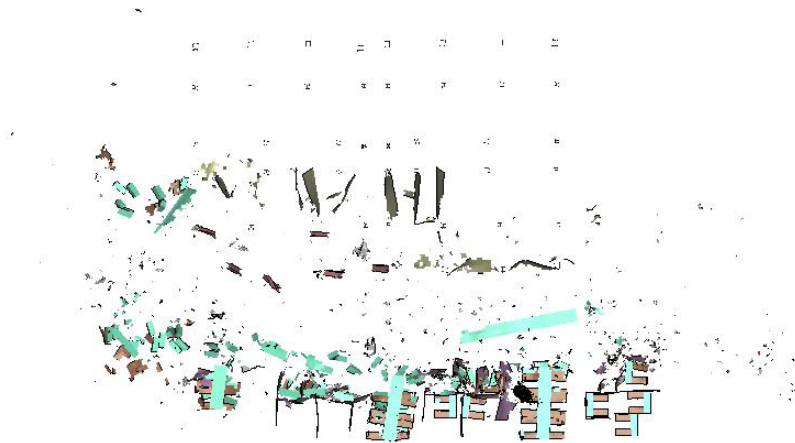
Figure 7-61. Calculated floor 81 contents and fuel distribution (more severe case).

The calculated damage to the WTC 2 contents for the more severe impact case is shown in plan views for floors 80 and 81 in Figure 7-60 and Figure 7-61, respectively. A comparison to the calculated damage for the base case WTC 2 impact analysis indicated that the tower contents damage zone was similar, with a slight increase in damage for the more severe impact.

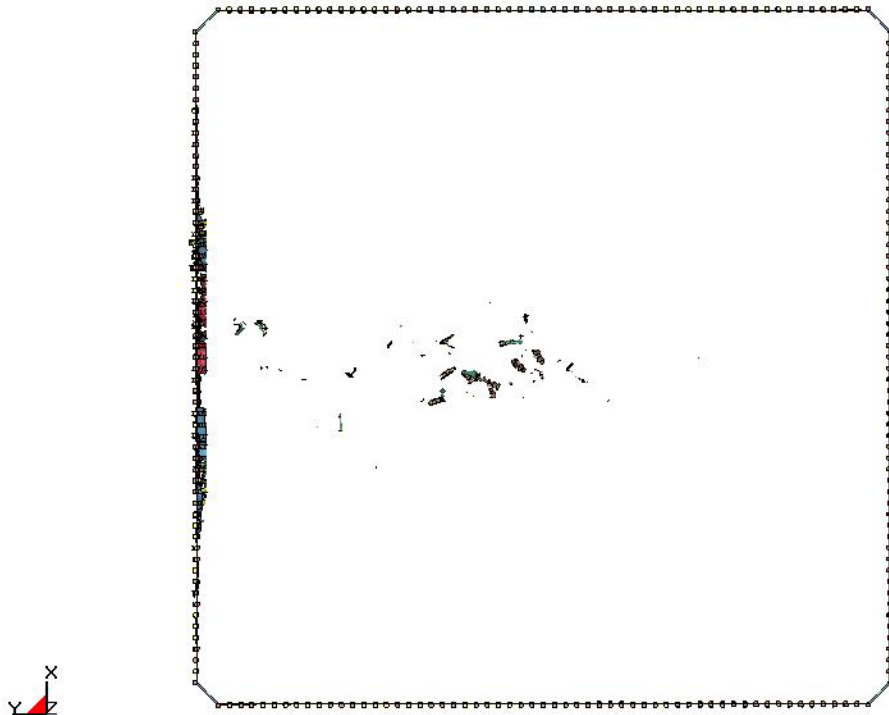
(b) Calculated landing gear debris (t = 0.71s)

Figure 7–66. Base case aircraft debris distribution in WTC 1.

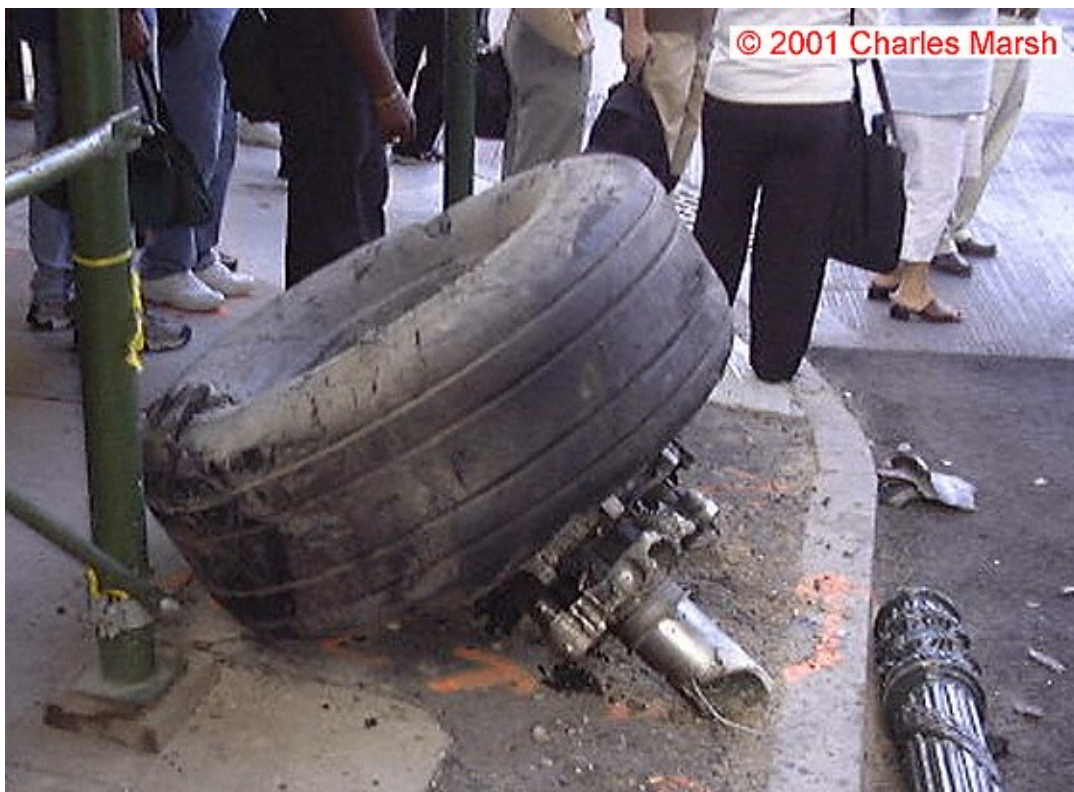
Figure 7–69. Landing gear found at the corner of West and Rector Streets.

it is postulated that the landing gear debris that landed at the corner of Rector St. and West St. also exited through this panel location.

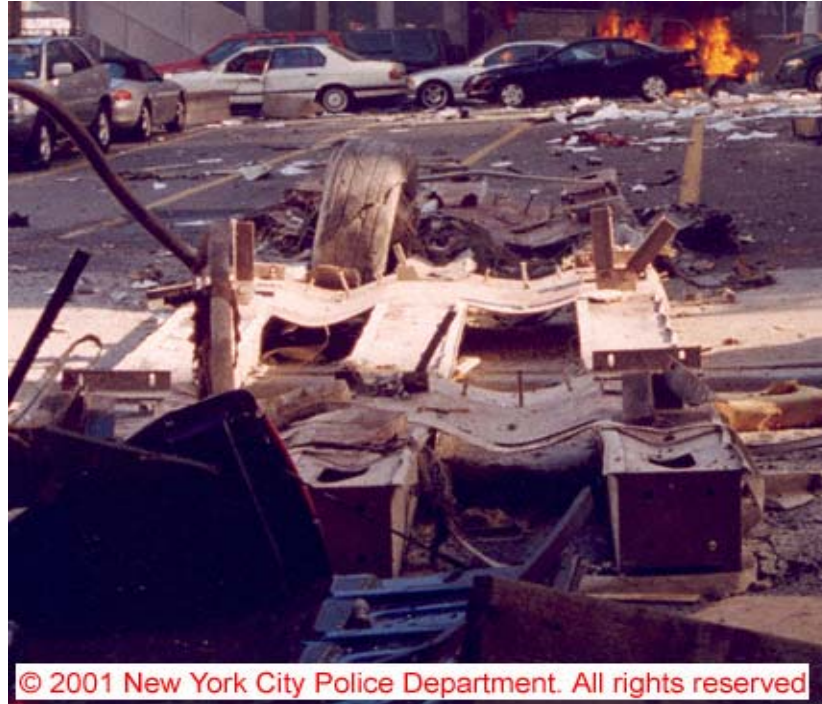
Figure 7–70. Landing gear found embedded in exterior panel knocked free from WTC 1.

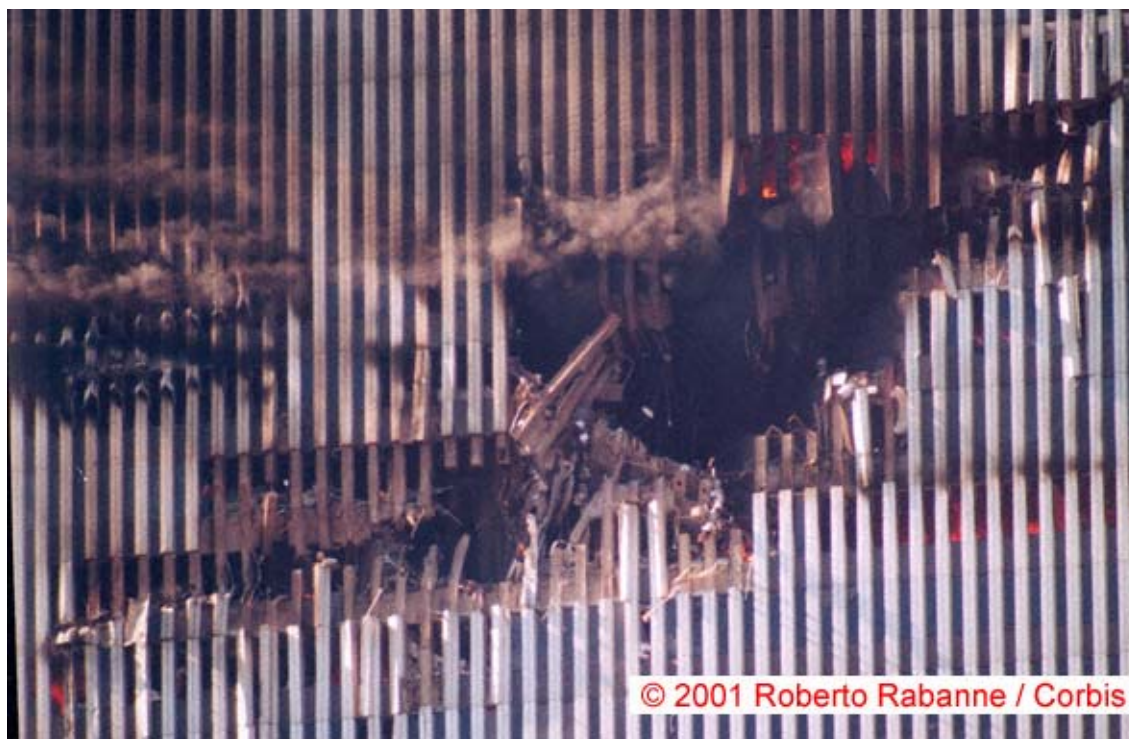
One location where the damage to the WTC 1 truss floors could be observed was through the opening in the tower exterior produced by the aircraft impact. A photograph of the impact damage on the north face of WTC 1 is shown in Figure 7-72(a). The magnitude of damage was difficult to quantify as a result of

the strong contrast in lighting between the tower interior and exterior and the smoke inside the building. However, the photograph shows that the truss floor was heavily damaged and/or removed in the primary impact zone. The depth of the floor damage extending into the tower could not be determined.

(a) Observed Damage

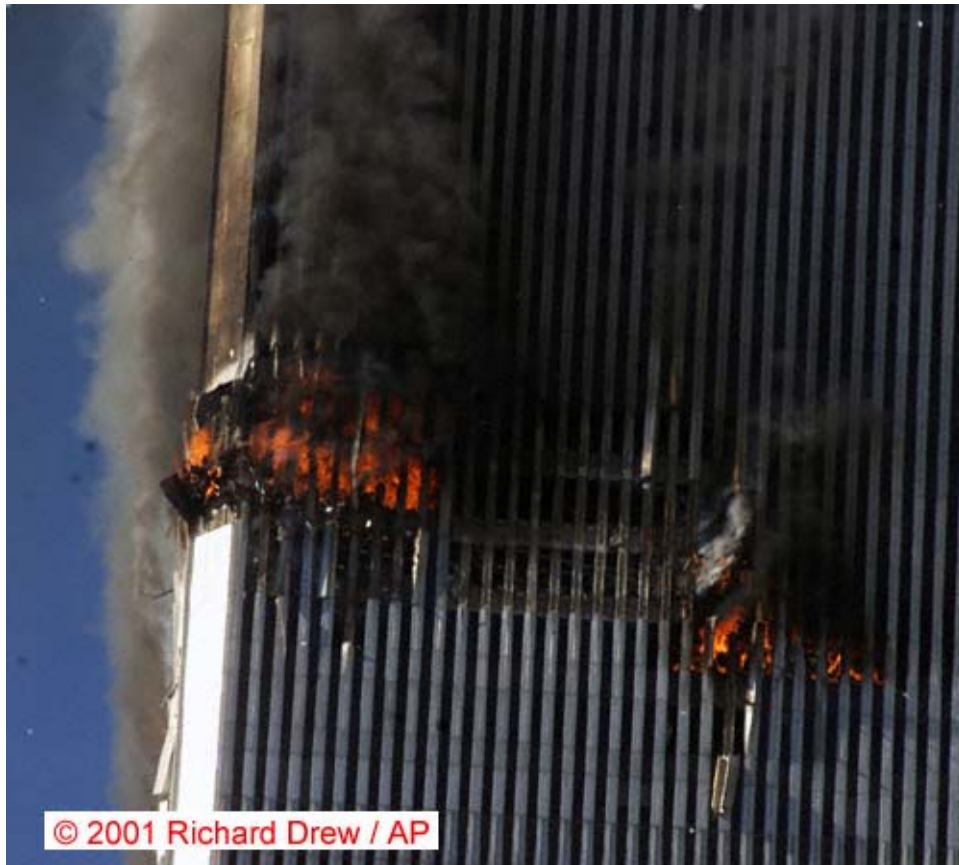
Figure 7–74. Impact damage to the northeast corner of the exterior wall of WTC 2.

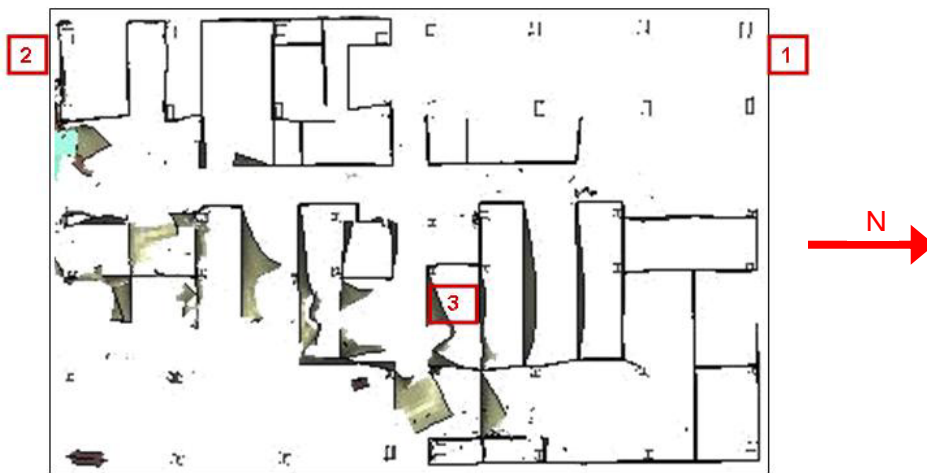
Figure 7–77. Base case stairwell disruption on floor 78 in WTC 2.

According to eyewitness interviews, stairwells 2 and 3 on floor 78 of WTC 2 were impassable (see NIST NCSTAR 1-7). Stairwell 1 (referred to also as stairwell A), which was located in the northwest corner of the core, was passable. The calculated base case stairwell disruption is shown in Figure 7–77.

Stairwells 1 and 2 (stairwell C) on floor 78 of WTC 2 were outside of the core column region as is shown in the figure. These stairwells were not included in the WTC 2 model. Therefore, a good assessment could not be made for stairwell 2. However, disruption to stairwell 3 (stairwell B) is shown in Figure 7–77. By the damage shown in the figure, the stairwell appears to be impassable. As no damage or debris was seen in the northwest corner of the tower, the top right in the figure, stairwell 1 in this area of the core was likely unaffected. Both of these assessments were consistent with the eyewitness accounts.

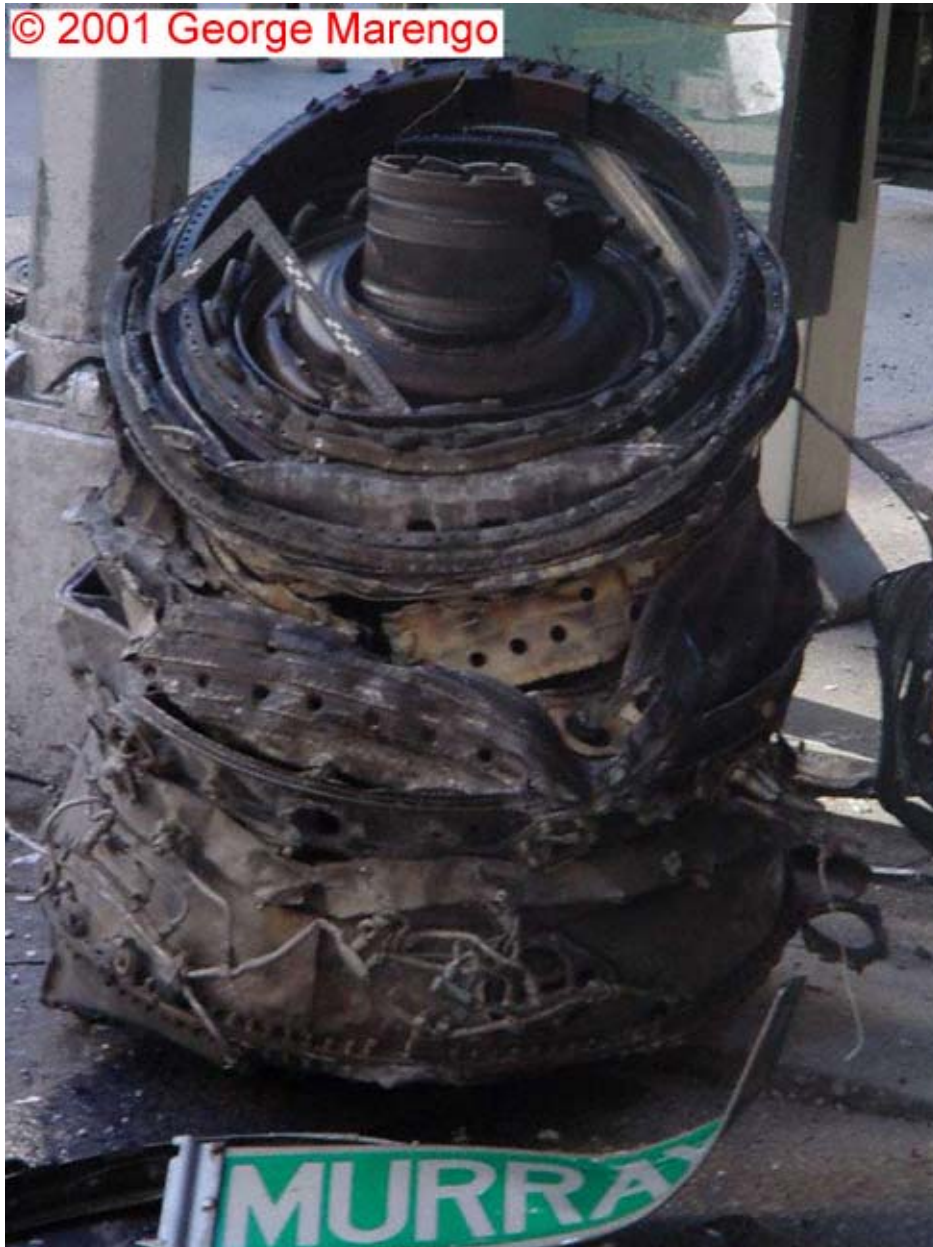
(c) Engine fragment found at Murray and Church St.

Figure 7-82. Calculated and observed engine damage.
